S J Johnson Associates Ltd

Defects report in connection with masonry cracking at No ## #### #####

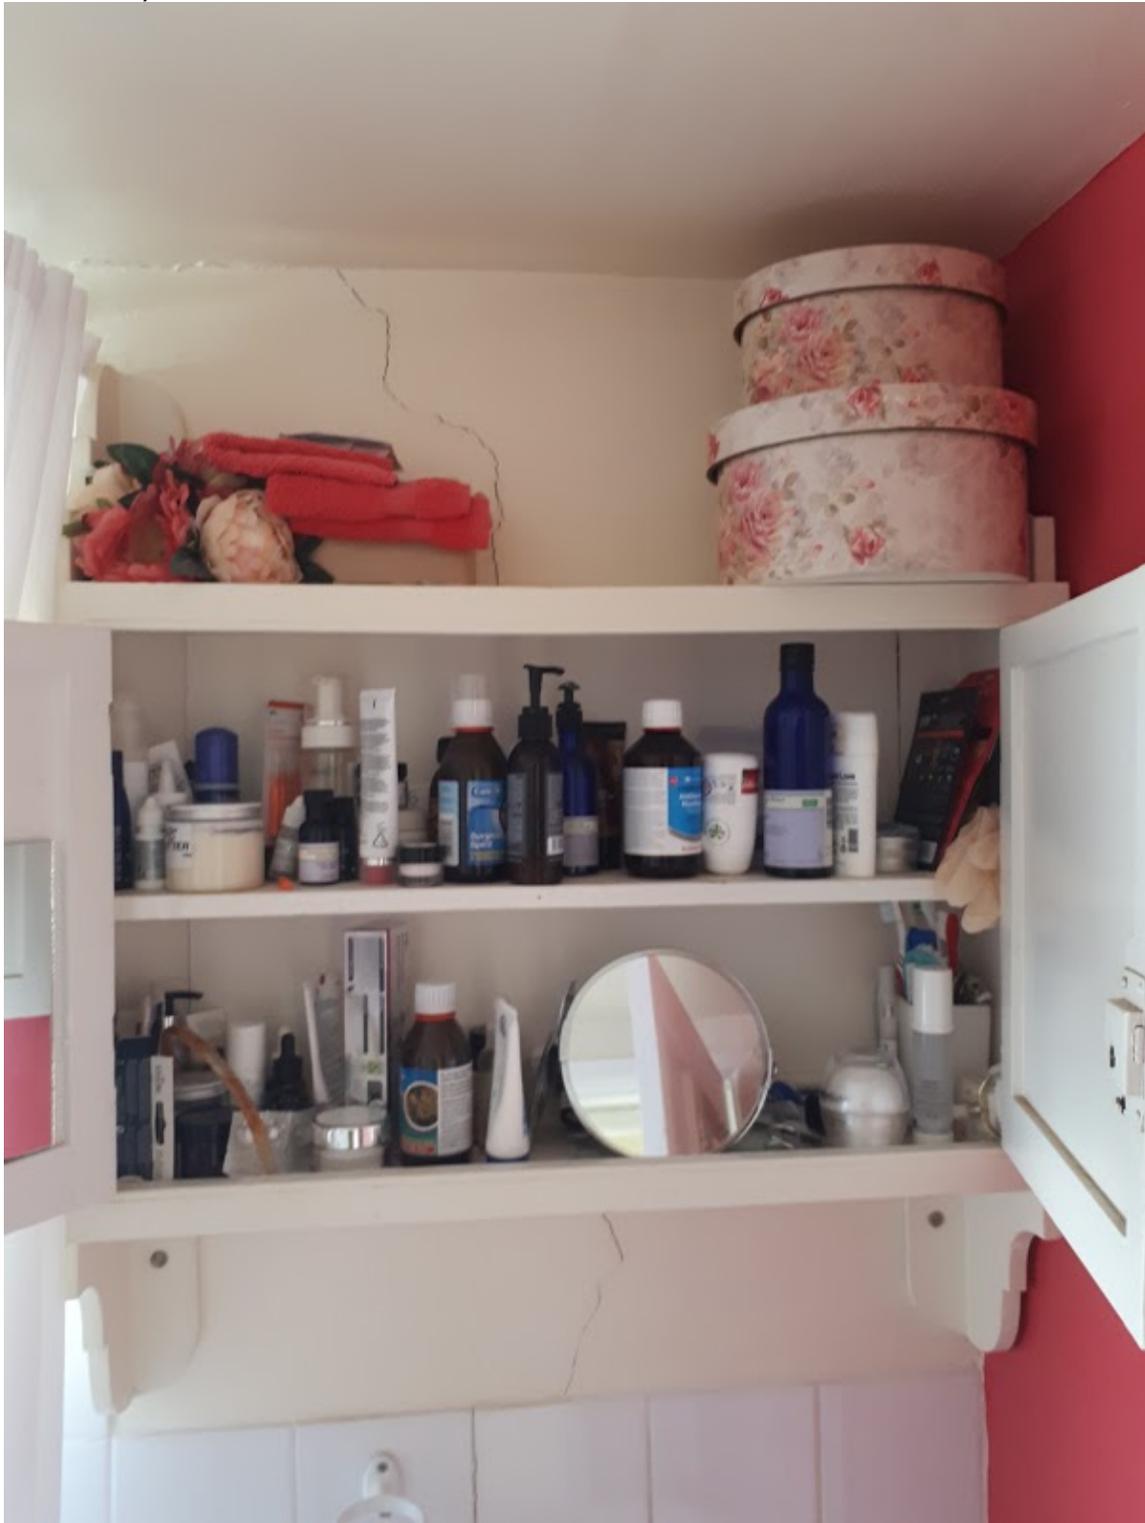
DEFECT LOCATION 1 – INTERNAL CRACKING OVER SINK 1ST FLOOR BATHROOM (PARTY WALL SIDE)

1.0 Bathroom - The survey commenced here, where Ref Plate 1.1 - slight cracking was observed radiating up from behind the sink. The cracking behind the sink propagating through tiled finishes which may have distorted its actual form. However as the cracking continued up beyond the tiled splash back above the sink it appears to widen as it approached the ceiling. Damp meter readings were taken at multiple locations across the wall but no evidence of damp was found here.

PLATE 1.1 – 1-2mm SLIGHT CRACKING THRU TILES RE-APPEARING AT 2-3MM ABOVE CUPBOARD

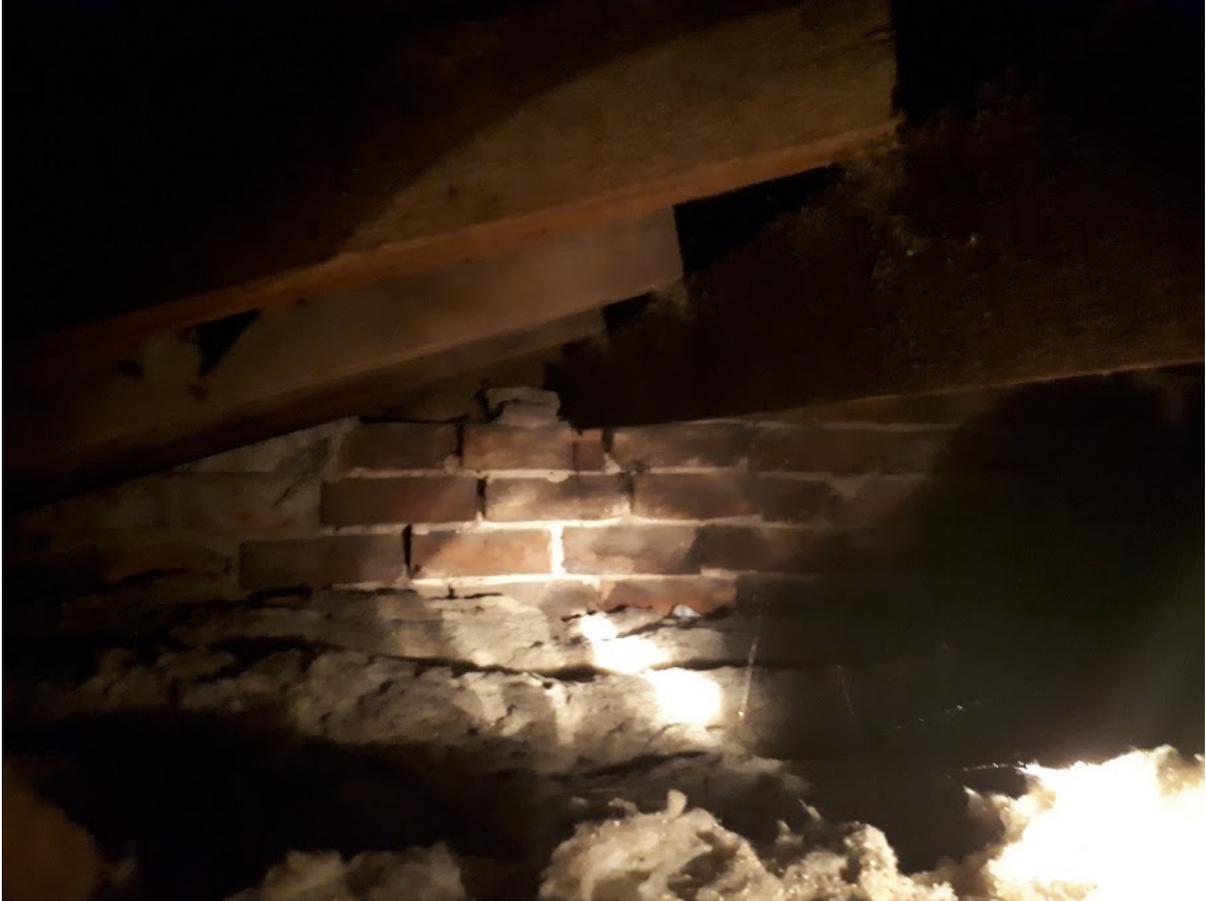
DEFECT LOCATION 2 – CRACKING AND BULGING ADJACENT TO ROOF PURLIN IMMEDIATELY ABOVE BATHROOM

2.0 Roof Space - The cracking was followed up into the roof space, as access is limited by a very small hatch, remote observations were made with adequate illumination. Observations here Ref Plate 2.1 showed both cracking and distortion with the fire/party wall appearing to lean forward slightly to the eaves side of the purlin bearing. It is noted that the roof has been modified at some earlier time and that there has previously been an additional purlin closer to the ridge. It is further noted that bed joints are not as well filled as they would be in more visible masonry, but this is normal. Therefore neither of these matters are considered detrimental as the load arriving at what is a relatively small purlin should be insignificant for a wall of this construction.

PLATE 2.1 – WIDE CRACKS EAVES / LHS OF PURLIN

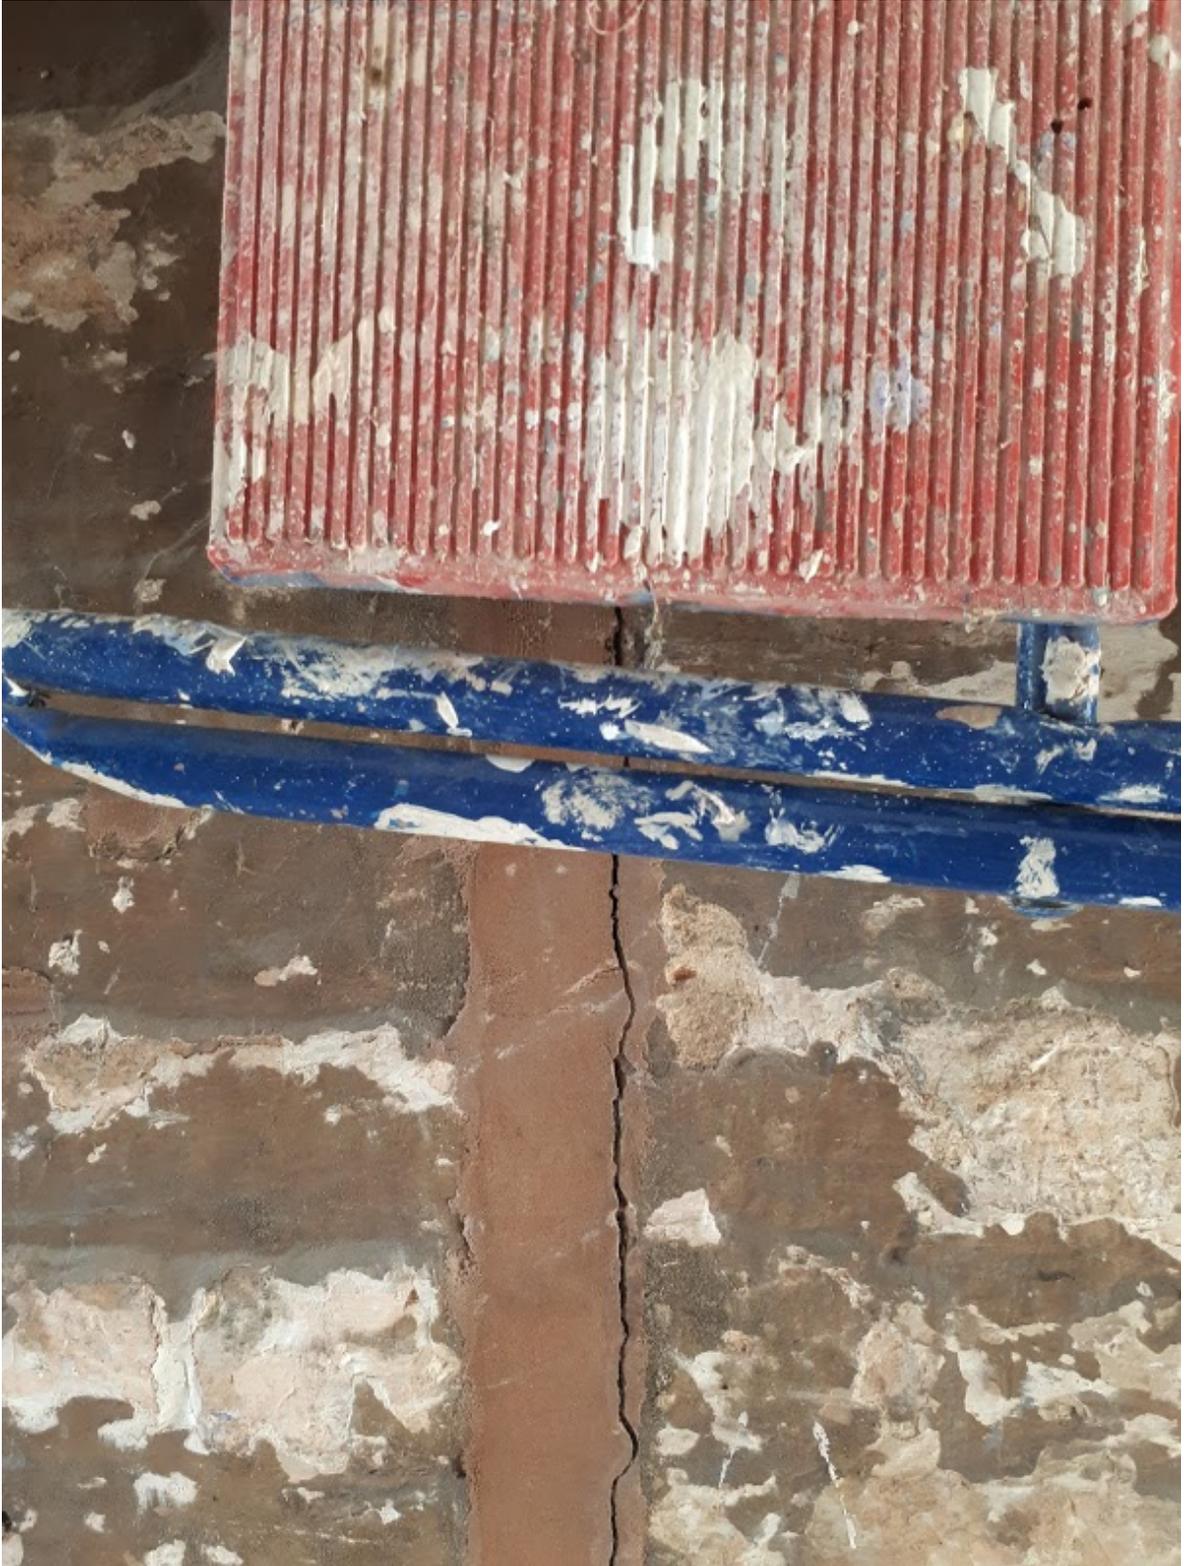
DEFECT LOCATION 3 – EXTERNAL SLIGHT 2mm TO MODERATE 7mm CRACKING AT BUTT JOINT - SEE FOLLOWING PLATES.

PLATE 3.1 – STOP / START UN-COURSED BUTT JOINT WITH 1-2mm CRACKING AT MID HEIGHT

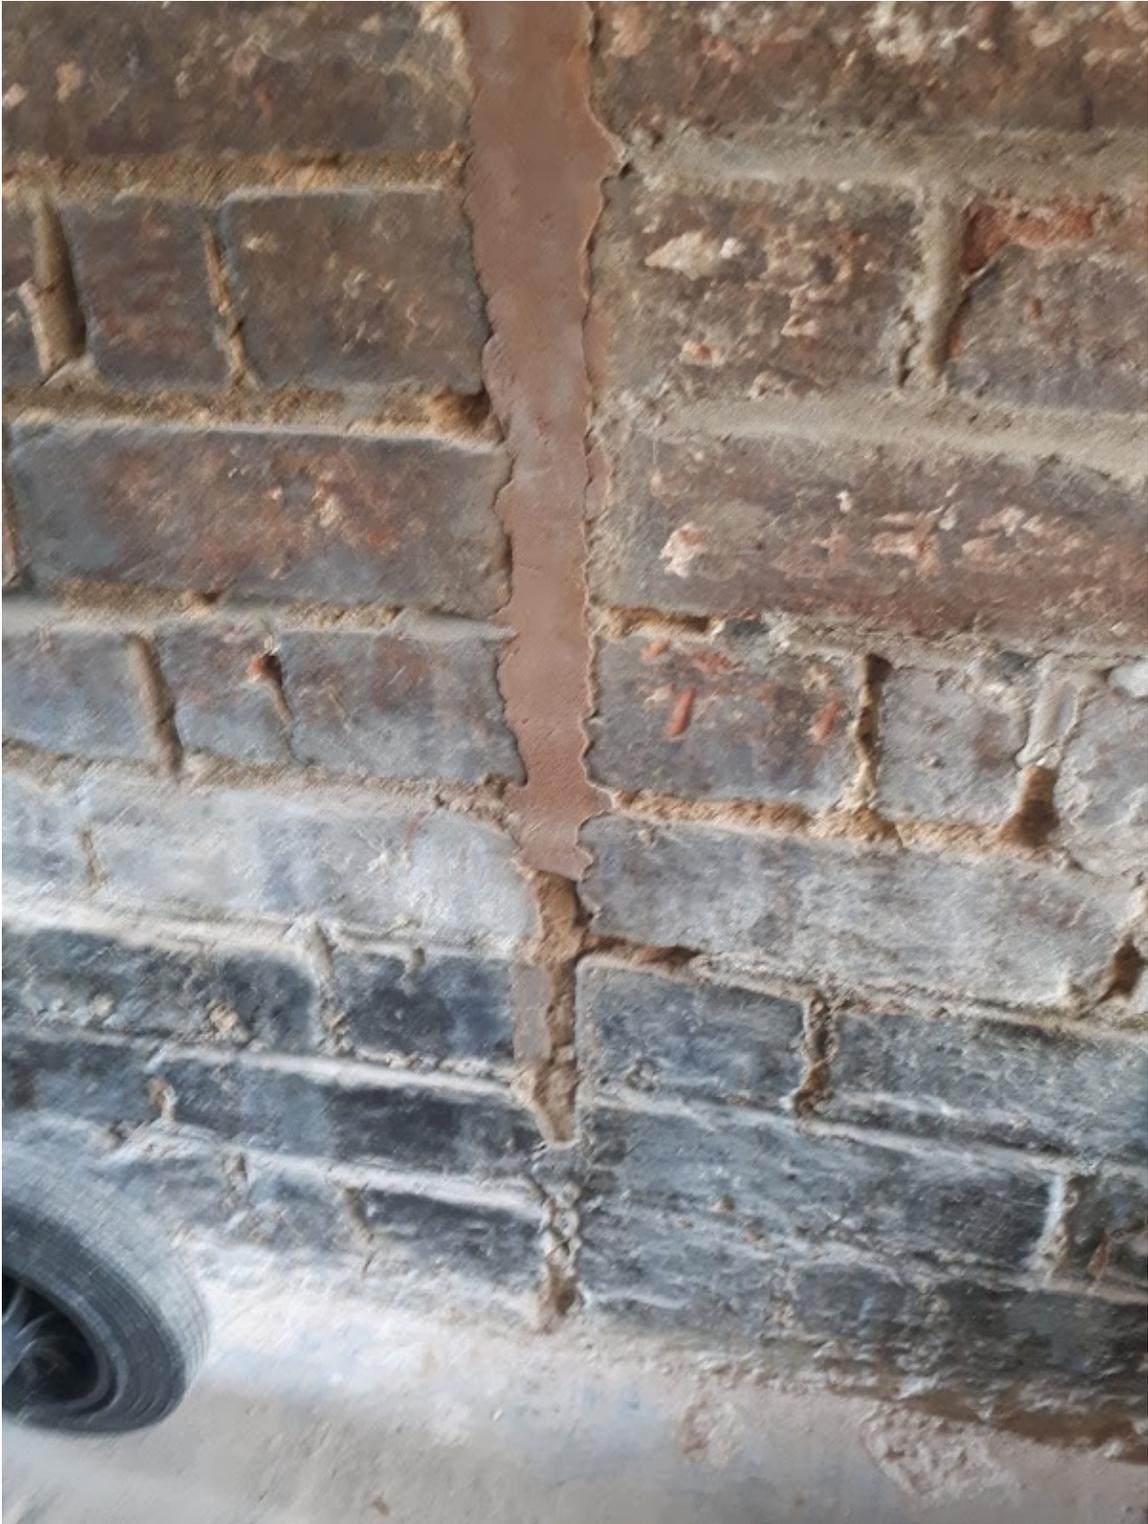
It is also noted that there has been a earlier mortar repair here the width of which suggest moderate >5mm to severe up to 25mm cracking. More recent cracking post repair (understood to have happened several years ago), shows new slight 2mm to moderate 7mm cracking suggesting that the processes causing this are still on going.

PLATE 3.2 – CRACKING MANIFESTING FROM PATH FLOOR – WIDENING AS IT CONTINUES UP. EVIDENCE OF A MORTAR REPAIR BELIEVED TO HAVE BEEN UNDERTAKEN SEVERAL YEARS AGO.

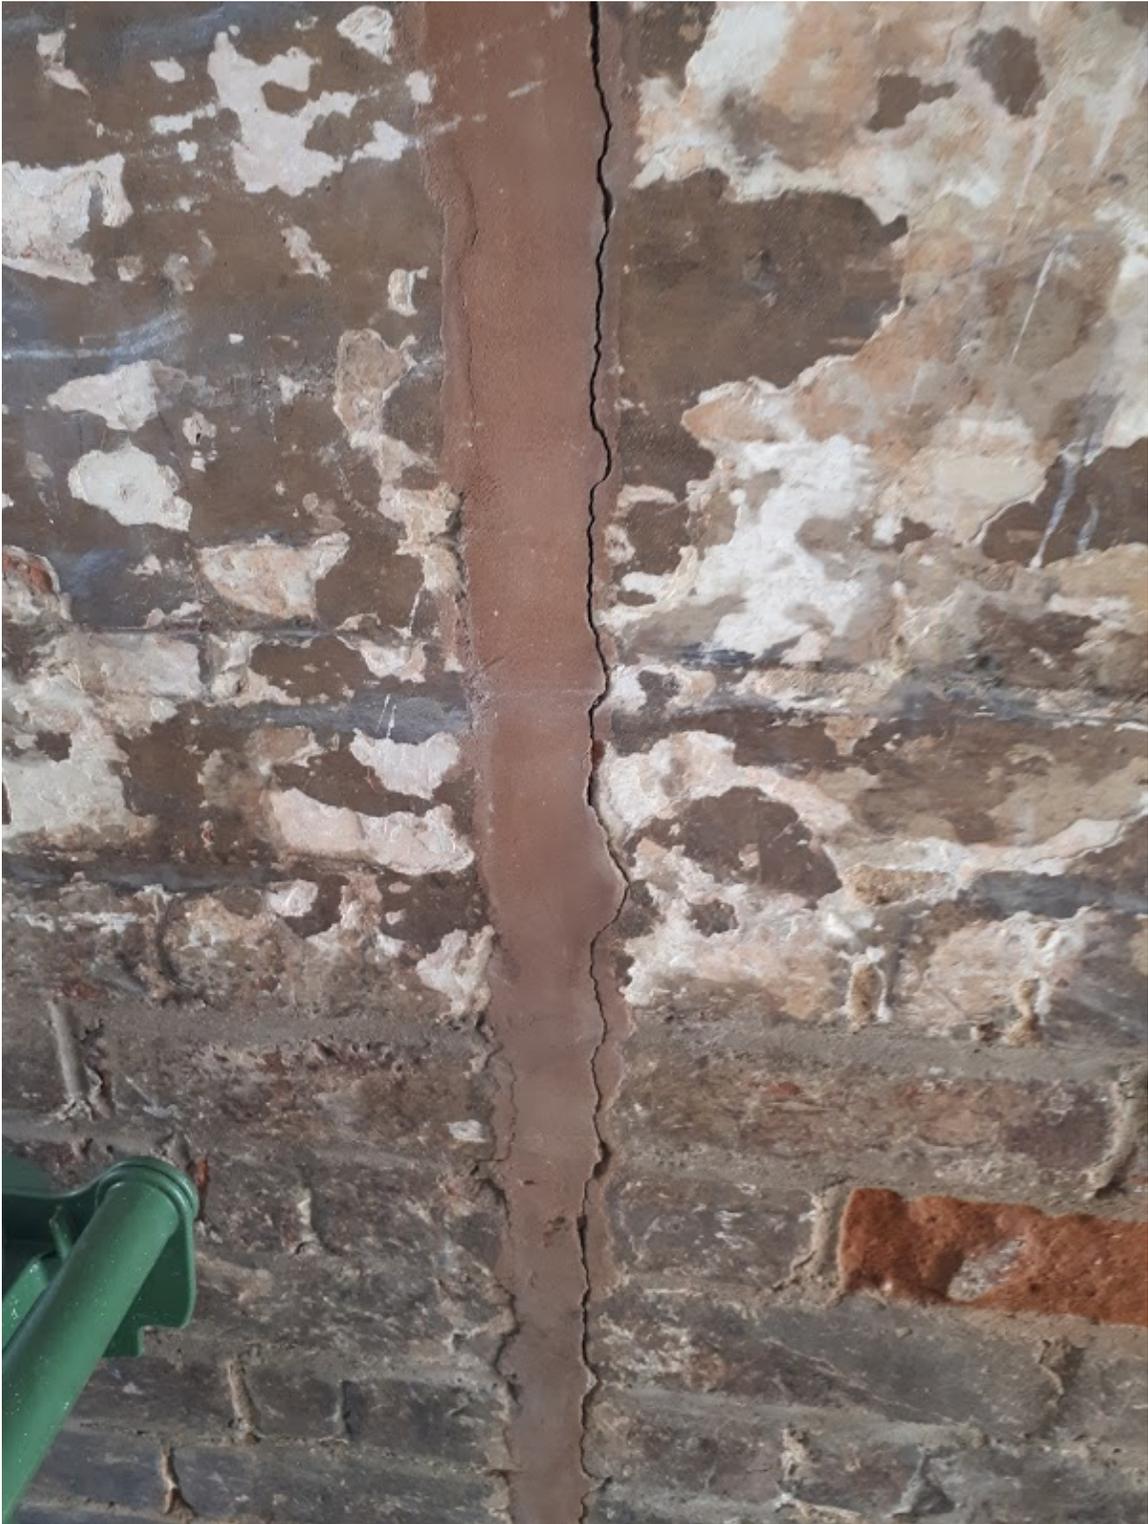
PLATE 3.3 – CRACKING AT MID HEIGHT SHOWING REPAIR FAILING ON RHS – THICKNESS OF EARLIER REPAIR CLEARLY WIDENING AS IT CONTINOUS UP – CURRENT CRACKING 2-3mm.

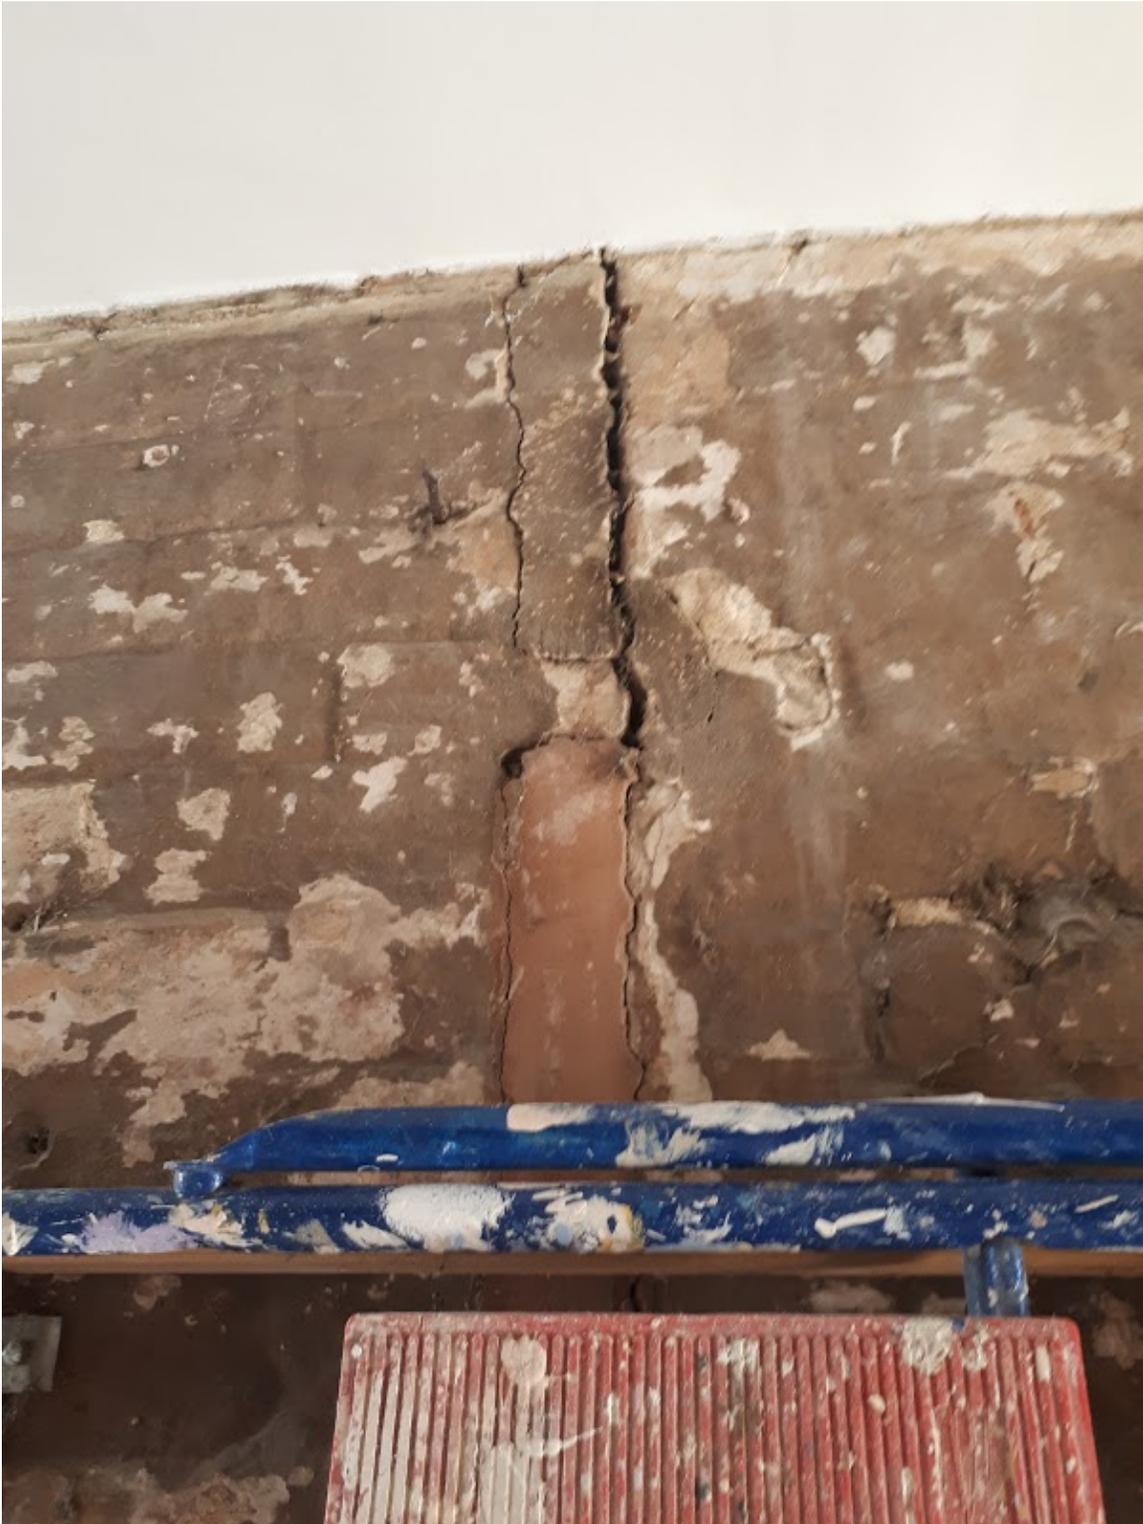
PLATE 3.4 – CRACKING AT 1ST FLOOR SOFFIT LEVEL – EVIDENCE OF FLOOR BEAM IN ADJOINING PROPERTY NO 26 LOADING LHS OF MASONRY JOINT. SEPERATION OF APPROX 7mm OBSERVED ABOVE BEAM TO THE UNLOADED RHS - (LADDER IN THE FOREGROUND)

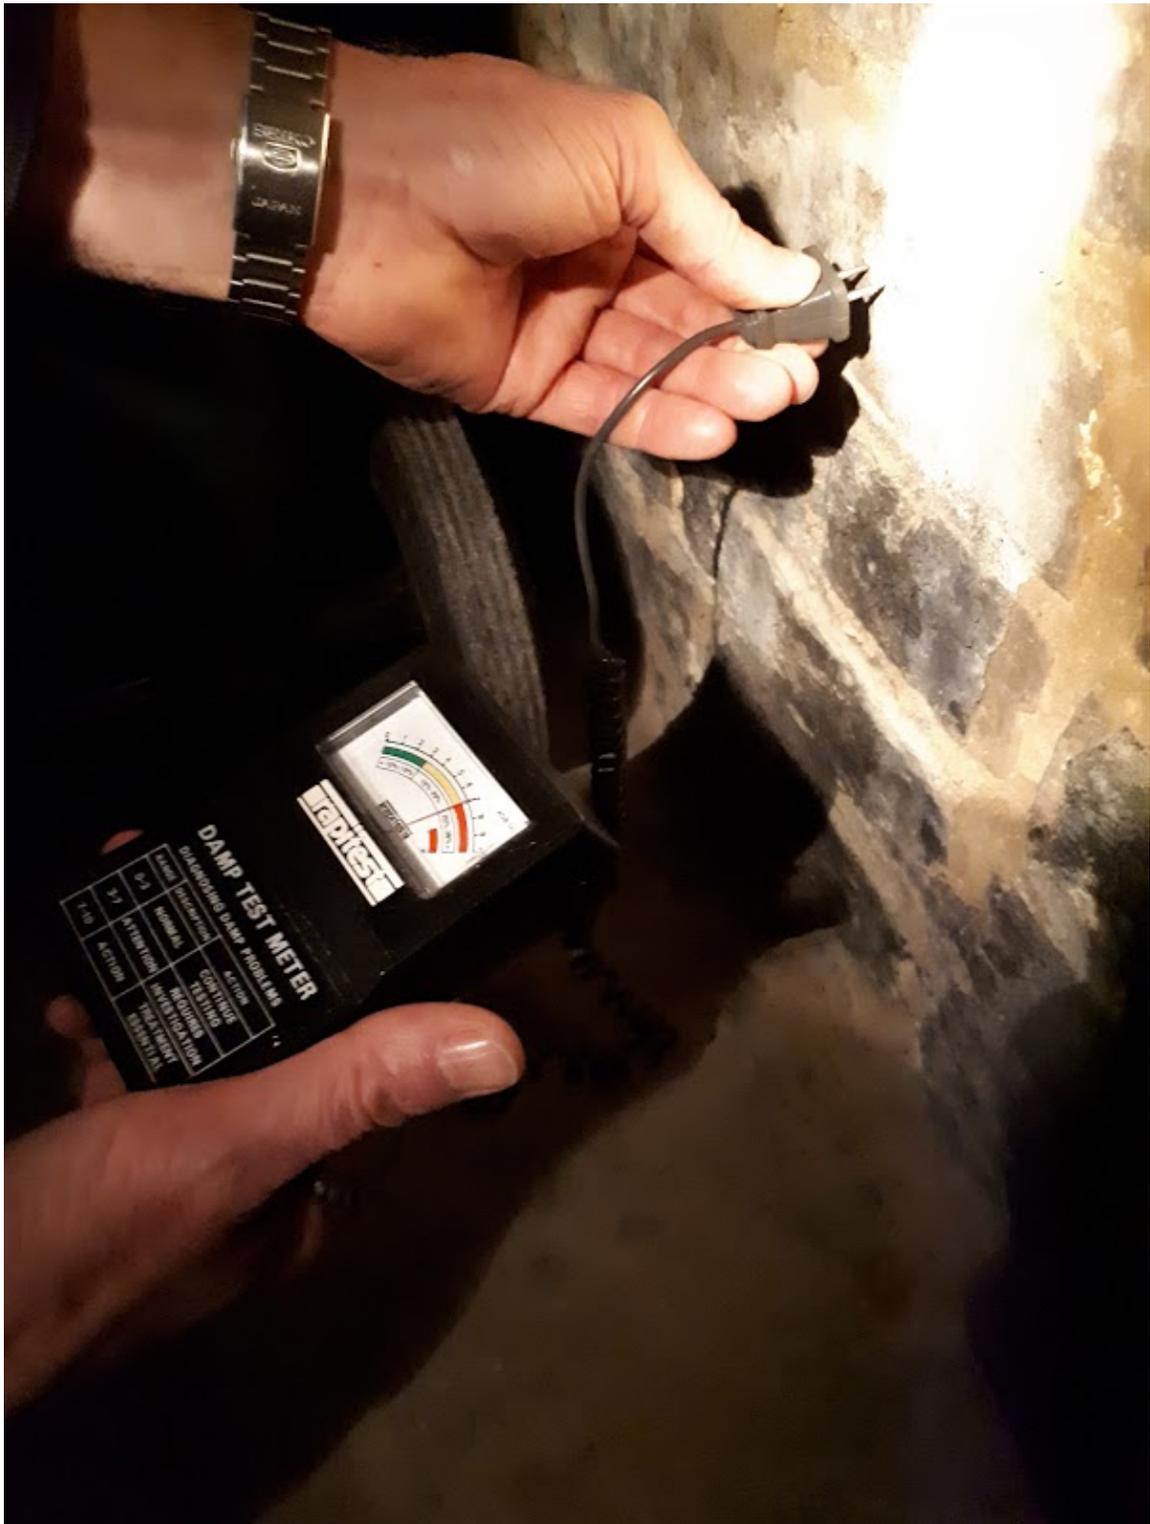
Damp meter readings show high levels of moisture locally around the cracking, leading one to believe a leaking drain may be present below or some other form of escaping water from within the adjacent property. A soil vent pipe was observed over the party fence of No 26 and this should be investigated further.

PLATE 3.5 – SIGNIFICANT DAMP READINGS ACROSS WALL, ABOVE DARKER DENSER BRICKS PROBABLY USED IN THE 19TH CENTURY FOR DAMP RESISTING PROVISION

1. Identify the mechanism by which excessive damp is manifesting at the primary site of the defect and remedy it.
2. Having addressed point 1, place the cracking under observation by way of tell-tale-tags or similar to determine if the matter is addressed.
3. Should item 1 not have addressed these matters – look to masonry stitch the butt joint to ensure a more uniform load spread from the beam end within No 26. This could be done with the Ancon Helifix System, link to Anderton Structural follows who are approved installers for this product, please refer to www.ancon.co.uk for product details and other approved installers.
