<u>S J Johnson Associates Ltd</u> Chartered Structural Engineers

Foundation depth assessment report for tree (T1) identified as of concern by LABC

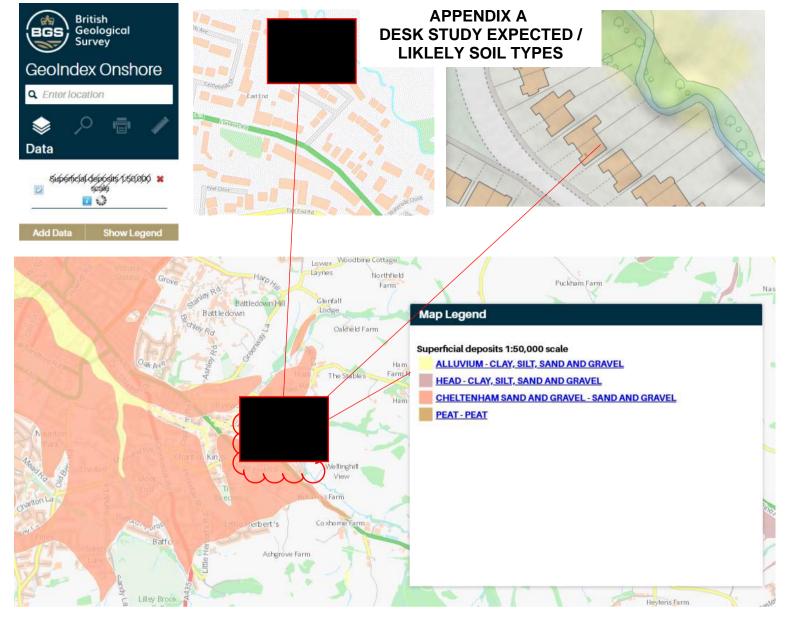
Foundation depths will be assessed in accordance with NHBC Chapter 4.2. The soil type in the absence of opening up / trial pit records Ref. BGS Mapping – **Appendix A** will be taken High Plasticity Alluvium Clay as deposits are mapped nearby.

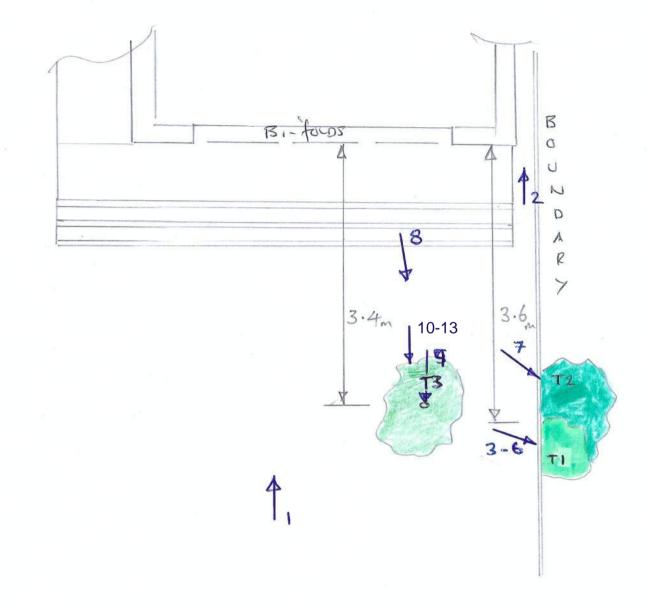
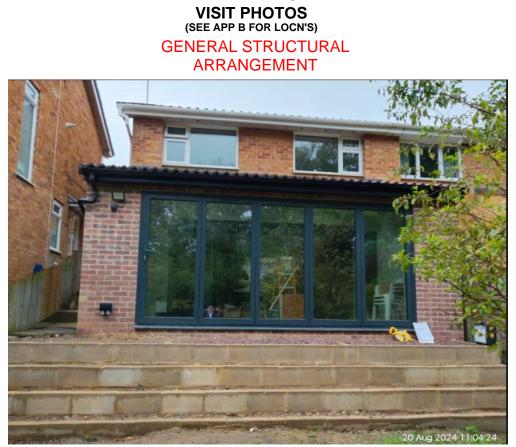
APPENDIX B TREE & VISIT PHOTO LOCATIONS

The property owner we understand at the request of the LABC Officer has requested an opinion as to the suitability of the now constructed extension's foundations with respect to planting specifically the tree identified by the Officer as of concern referred to here as Tree (T1) in this report – for tree locations see **Appendix B**.

As stated later on from observations in **Appendix C**, Tree (T1) is likely of the Cypress specifies, it's features suggesting most likely a Lawson Cypress. This being the case this is most likely the worse case tree for foundation affects, the surveyor as a duty of care has also checked trees (T2) & (T3) – for locations see **Appendix B**.
