S J Johnson Associates Ltd

Our Ref. 379/2024

Foundation assessment report for proposed re-use of previous conservatory Foundation + Soil type at formation etc.

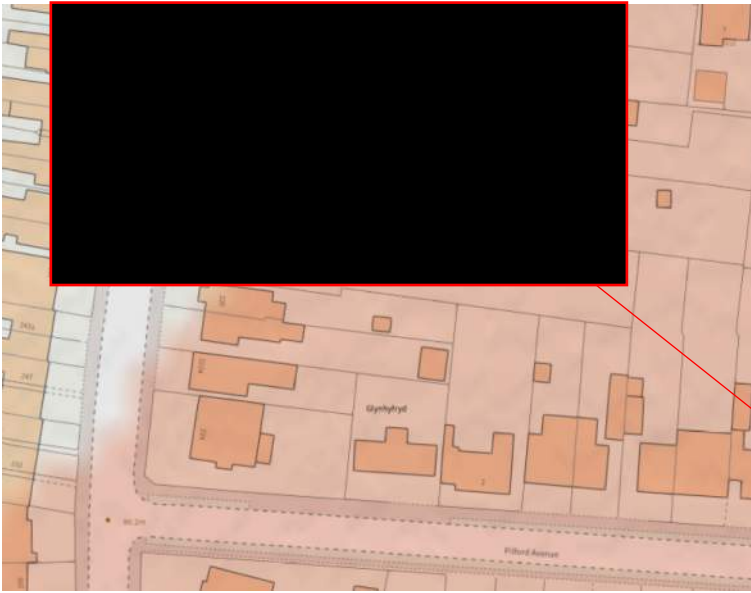
APPENDIX A - BRITISH GEOLOGICAL SURVEY DESK STUDY SOILS

As one would expect from the Geological Mapping – **Appendix A**, the soil observed was in part sandy in places – **Photos 3,9,10,11** the BGS map showing the legend extent of the Cheltenham Sand and Gravel very close but to the East of the property. Being outside of the defined map legend extent, places the site within the area of mixed superficial deposits and samples taken towards the Northern boundary (within the triangular excavation) confirm this appearing darker and to contain much (fine grain material) like clay or silt – **Photo 5 (Sample 1)** and **Photos (6-8)** the sampling location.

Ref. [3] - British Geological survey mapping

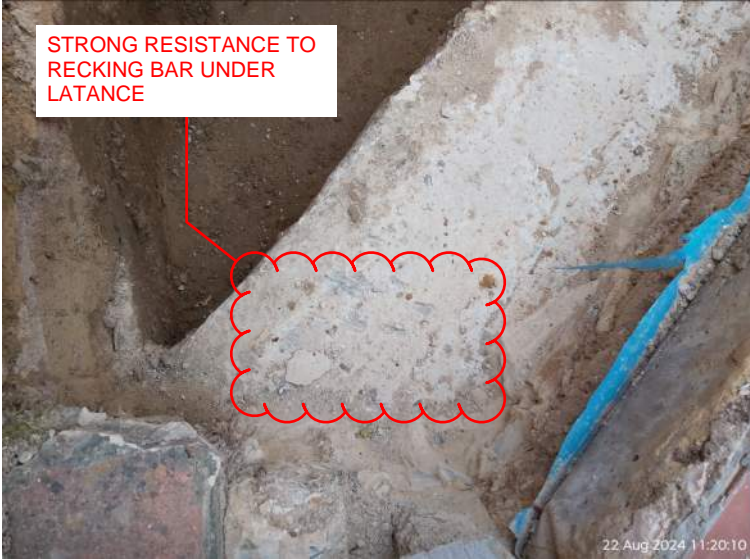
Strength testing undertaken today with the chisel end of a 10kg five foot breaking bar failed to make much of an impression on the concrete. The concrete where it could be tested once the latence had come off resisting well and refusing to breakdown or split, indicating **Ref [8]** a strength of at least that of GEN1 / ST2

and therefore from a strength aspect suitable for foundations - **Photos 1 & 2**.

01 - EX FND AT EDGE OF LOW LVL BLOCK WORK

3. **Existing Concrete – Section 2.2** - As the existing footing is only at a formation level of -700mm, this will need removing. Recognising that the strength of its concrete is very good – you will likely need to hire a Pneumatic breaker.

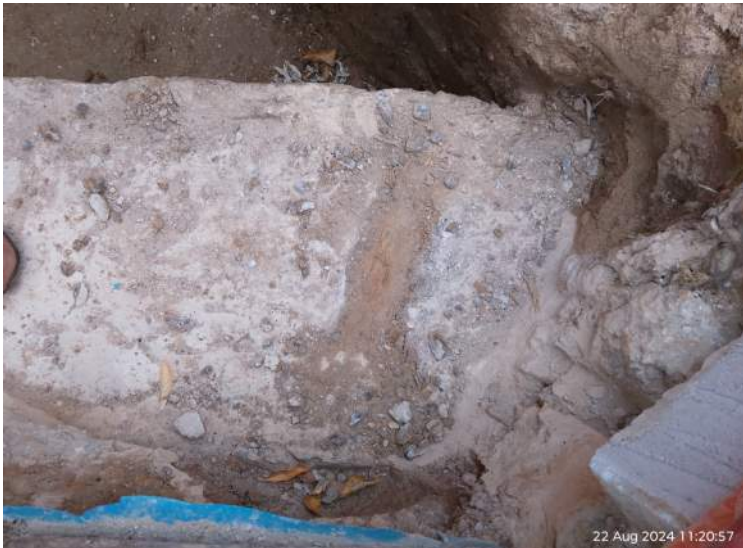
02 - EX FND AT ACCESS WAY - EMBEDDED SHUTTER - BUT OTHERWISE AS 01

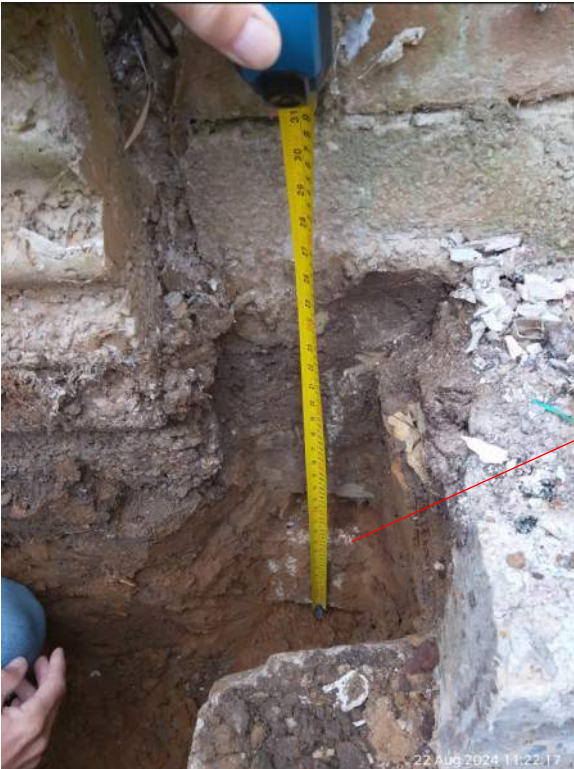
03 - EX FND UNDER TWO STOREY NEIGHBOURS EXTENSION

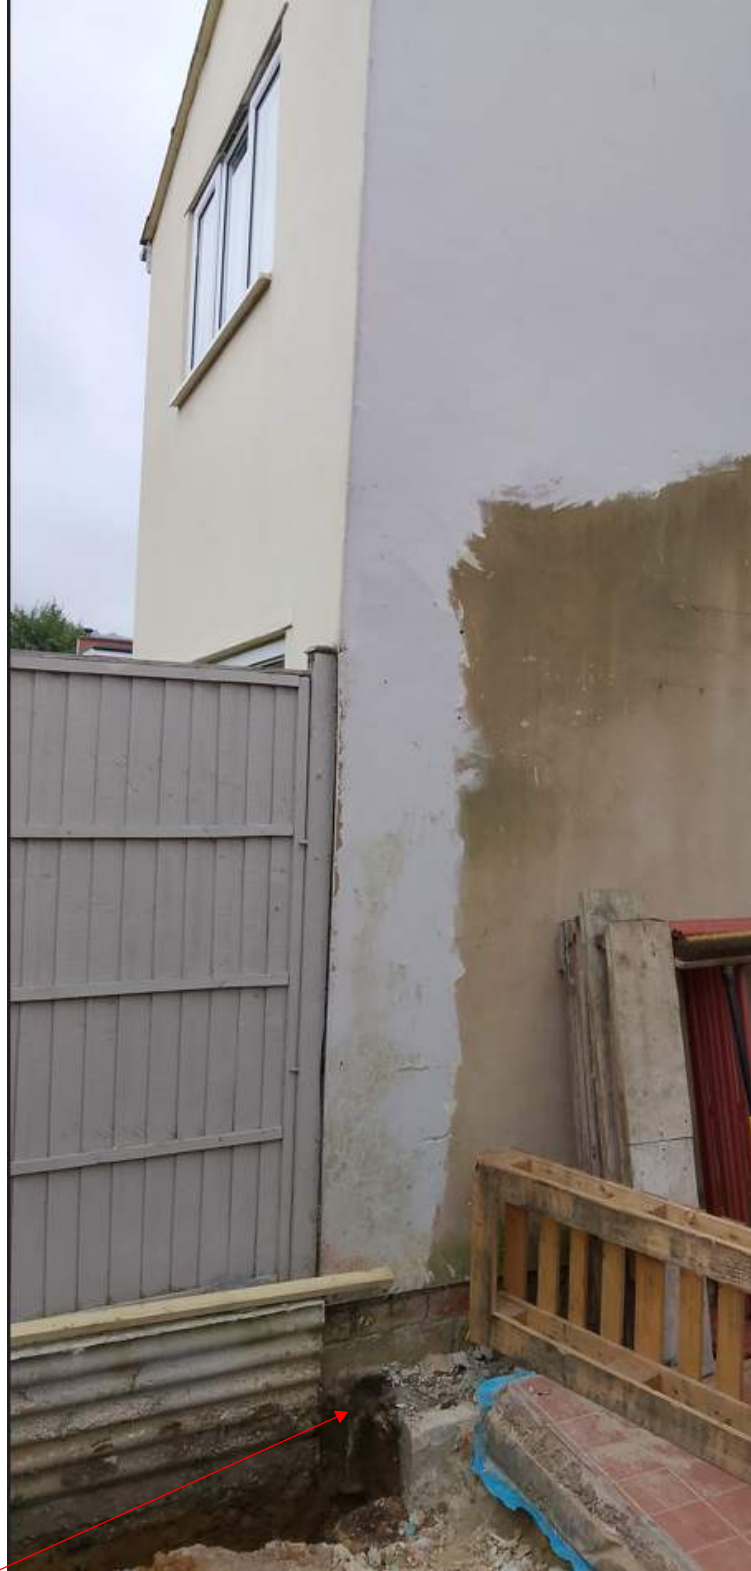
27 - EX FND UNDER TWO STOREY NEIGHBOURS EXTENSION

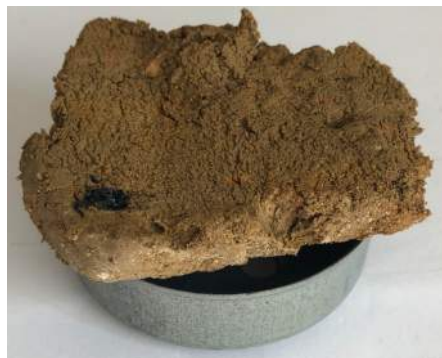
Test Sample - plan

Dry Strength Test. A pat of soil about 6mm thick is allowed to dry completely either naturally or in an oven. The strength of the dry soil is then assessed by breaking and crumbling between the fingers. Inorganic clays have relatively high dry strength, the greater the strength the higher the liquid limit. Inorganic silts of low liquid limit have little or no dry strength, crumbling easily between the fingers.

circa 6mm thick

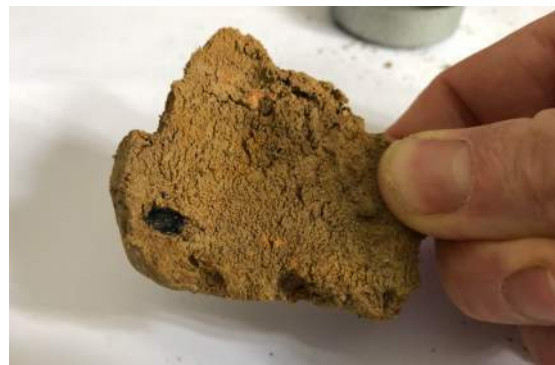
Summary result - high strength - indicating the presence of much inorganic clay of high liquid limit.

Test 1 - Considerable Finger Pressure - No Effect.

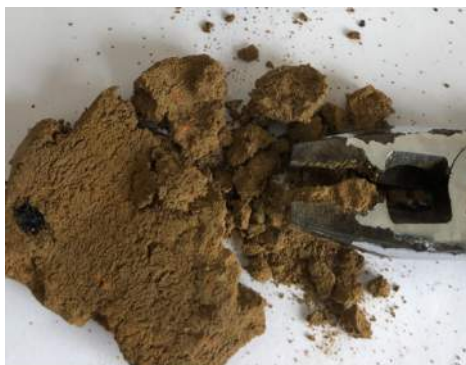
Test 2 - Took pliers to break the sample, the finger pressure in effective on smaller pieces.
